**Installation photos record**

Project: ASML Hong Kong Office

Date: 21 July 2018

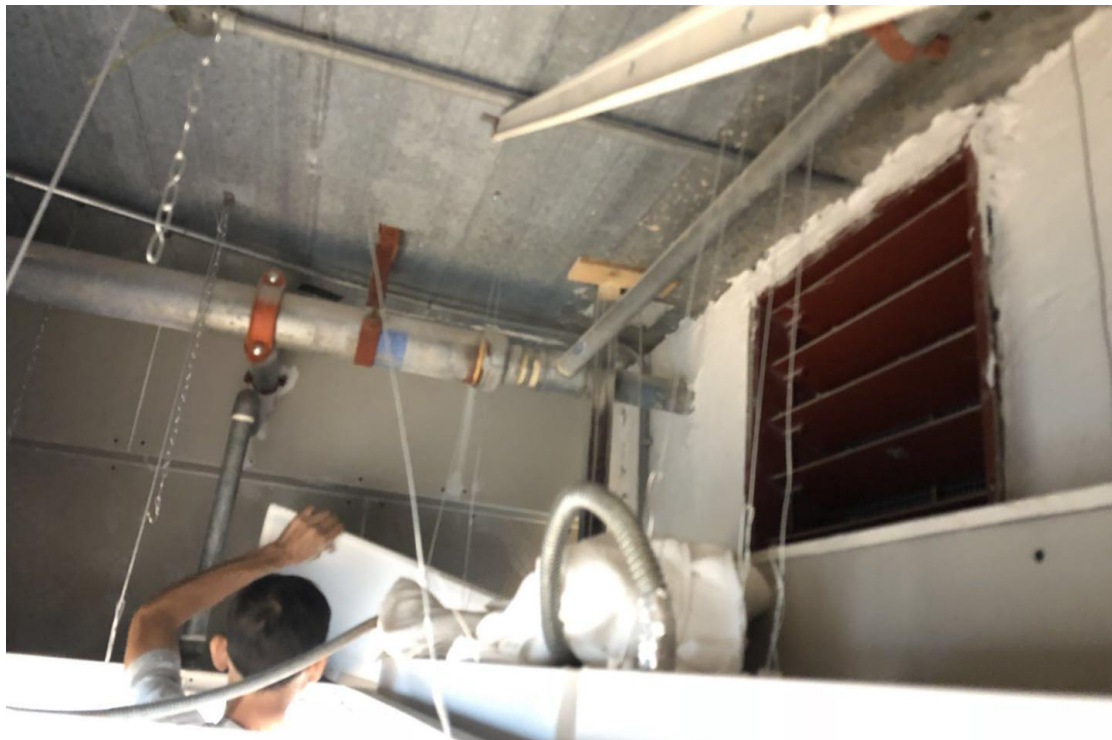
Ventilation Opening before treatment

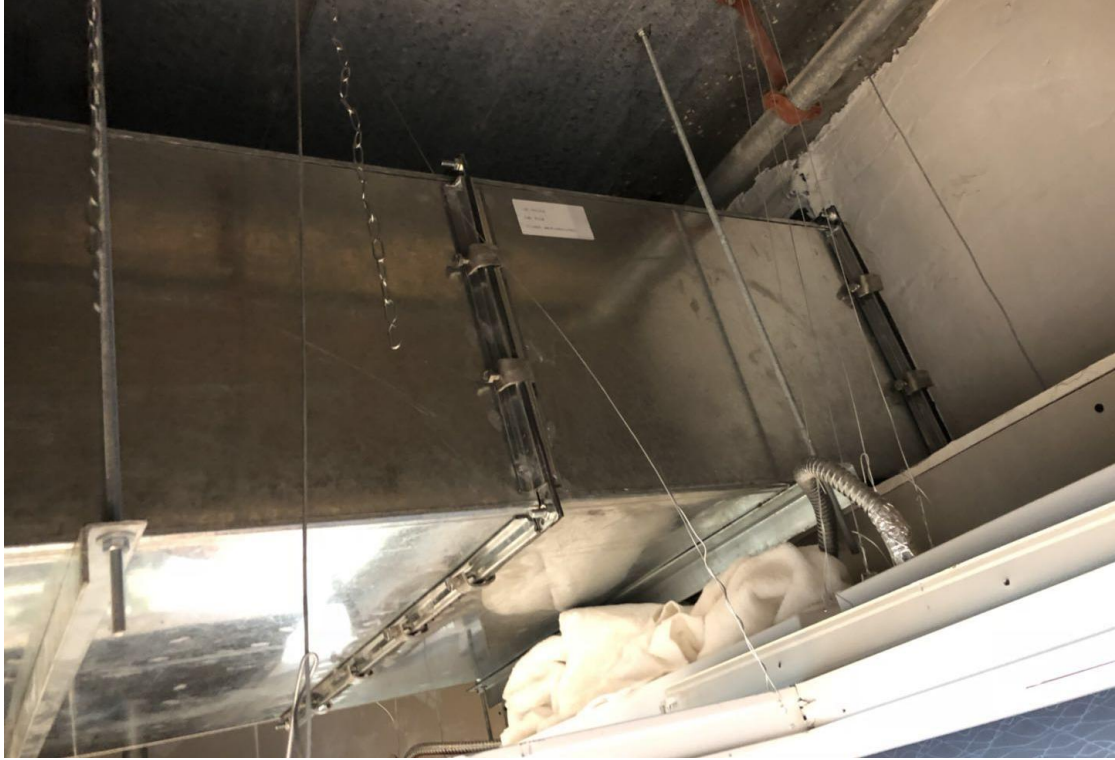
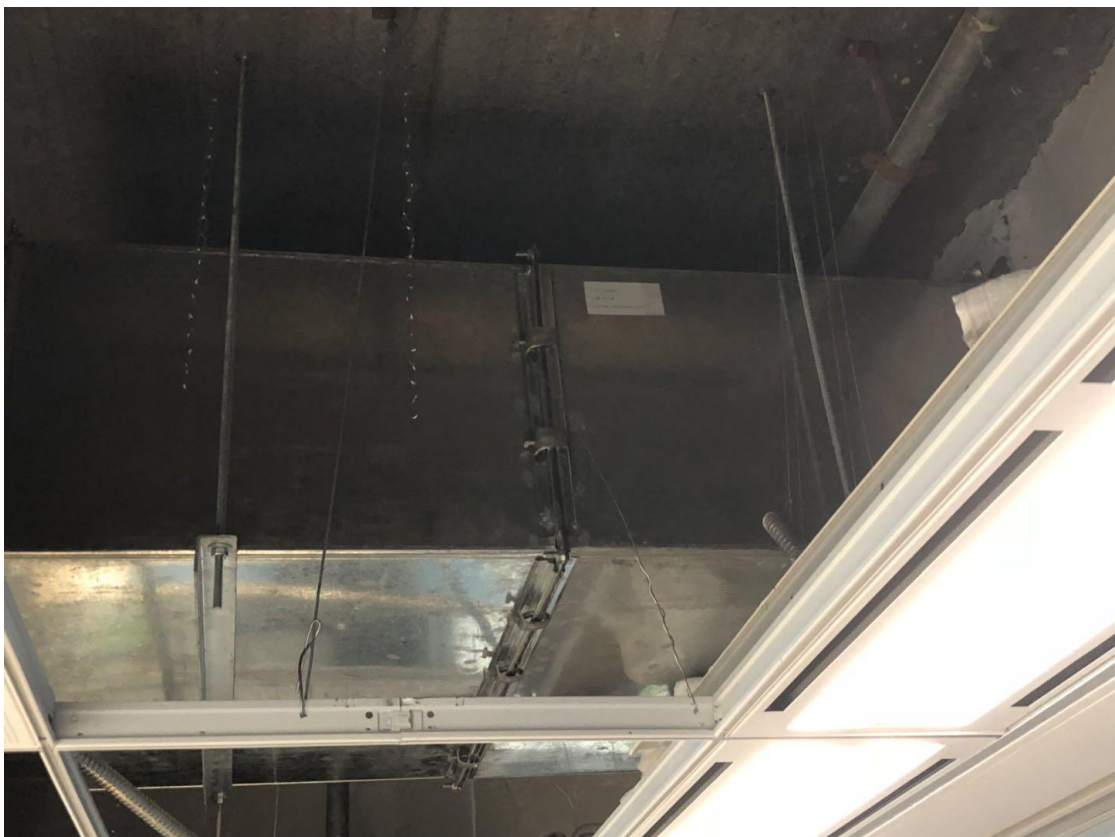
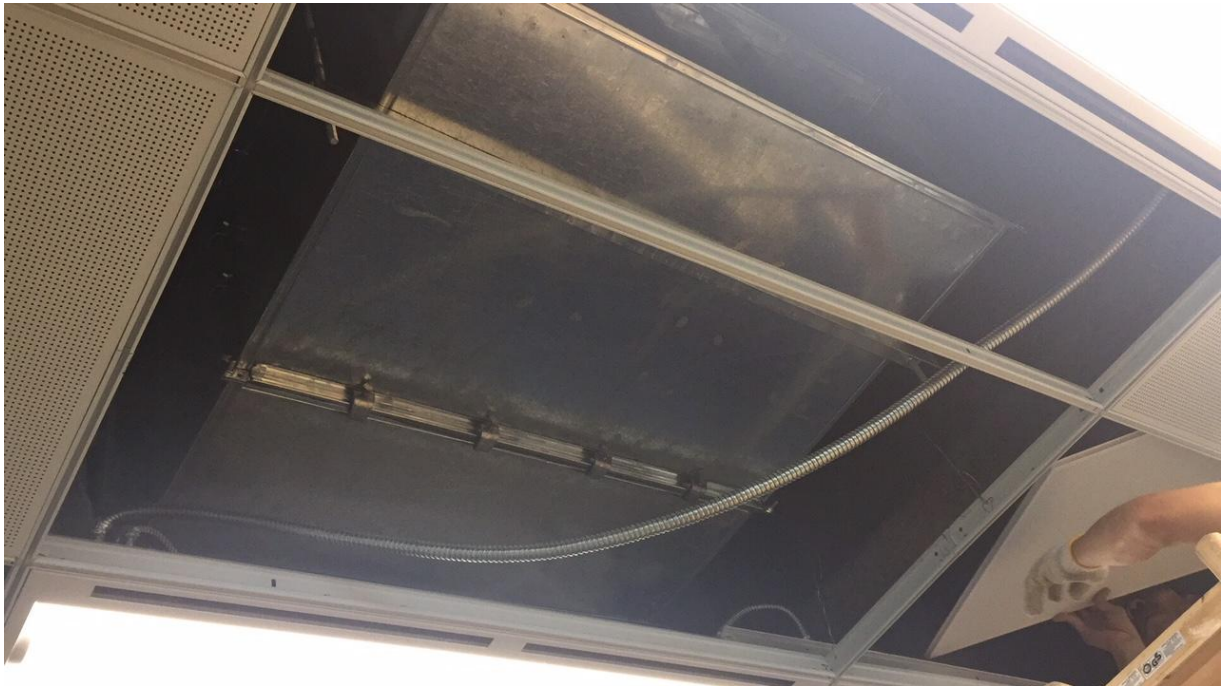
Completed installation conditions
